KEKB experience with crab cavities

Yoshiyuki Morita

KEK

- KEBB accelerator and crab crossing
- RF system
- Crab cavity commissioning
- Crab cavity operation

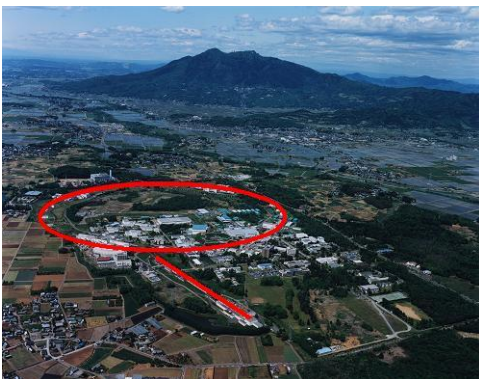
- Crab cavity location
- ~1 km away from the IP
- He refrigerator (8 kW@4.4K) for 8 SC cavities
- HP RF stations re-used for crab cavities

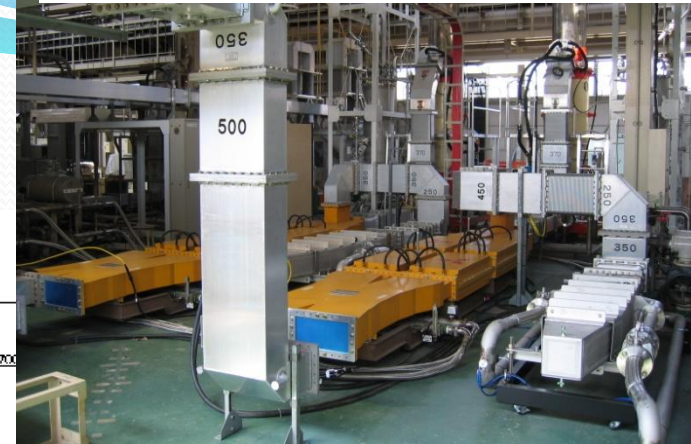
Two RF stations for crab cavities

Two RF stations for two crab cavities.
Two re-used klystrons.
One power supply to drive two klystrons.
Similar to the SC accelerating cavity stations.

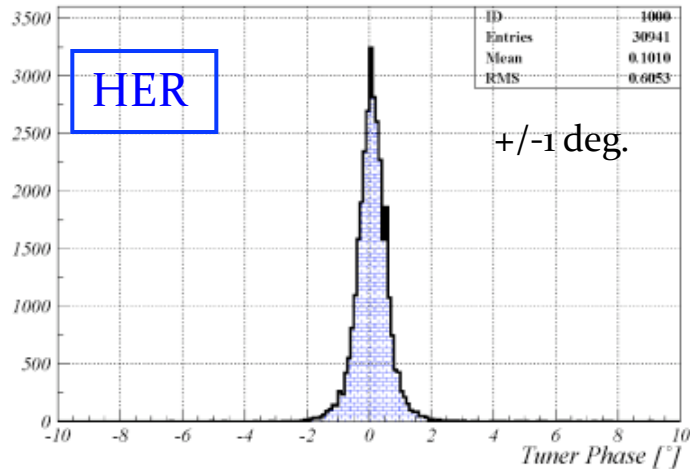
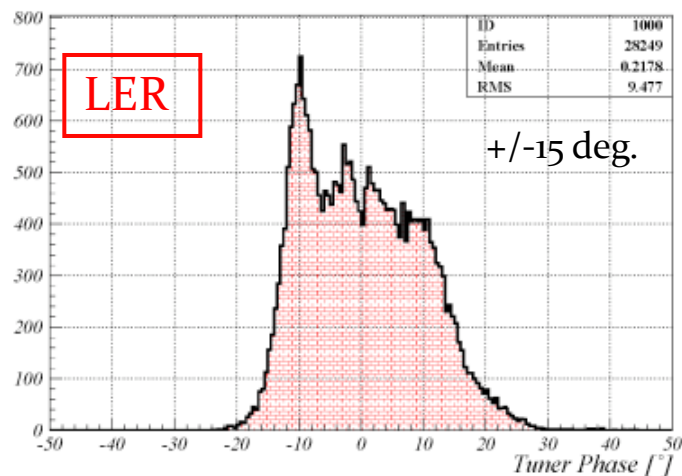
Tuner phase control

Distribution of tuner phase for $V_c > 0.3$ MV

The HER frequency tuner is well controlled.
Tuning phase stays within ± 1 deg.
The LER frequency tuner mechanism has a large backlash.
Tuning phase fluctuates about ± 15 deg.

- The LER tuner has large backlash behavior
 - Tuner phase fluctuates +/- 15 deg.
- Piezo actuator broke down
 - Frequency tuner operates w/o piezo actuator
 - Tuner phase fluctuation increased +/- 2 deg.
- LLRF still well controls crabbing phase even with large tuner phase fluctuation

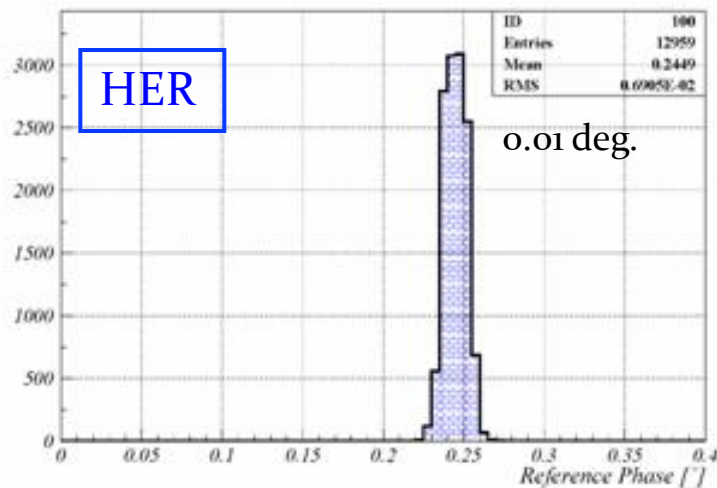
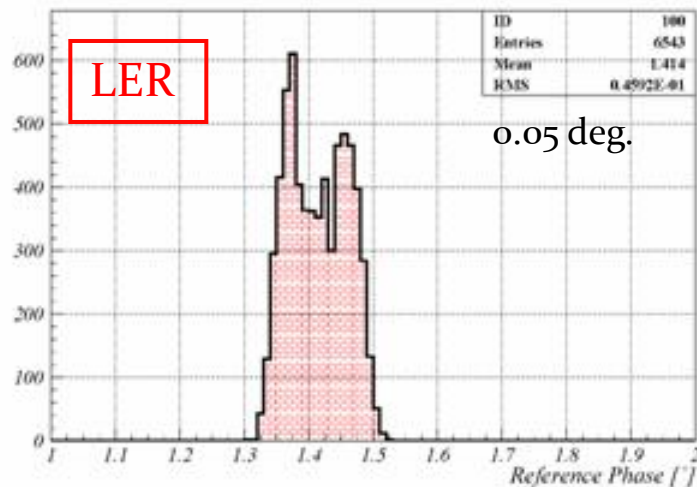
Crab phase control

Low level feed back loops well stabilize the cavity voltage and phase.
Phase distributes within
0.01 deg. in the HER crab cavity,
0.05 deg. in the LER crab cavity.

- Spectrum of pick up signal was analyzed and consistent with phase detector data.
- Phase fluctuation faster than 1 kHz is less than $\pm 0.01^\circ$, and slow fluctuation from ten to several hundreds of hertz is about $\pm 0.1^\circ$.
- They are much less than the allowed phase error obtained from the beam-beam simulations for the crabbing beams in KEKB.

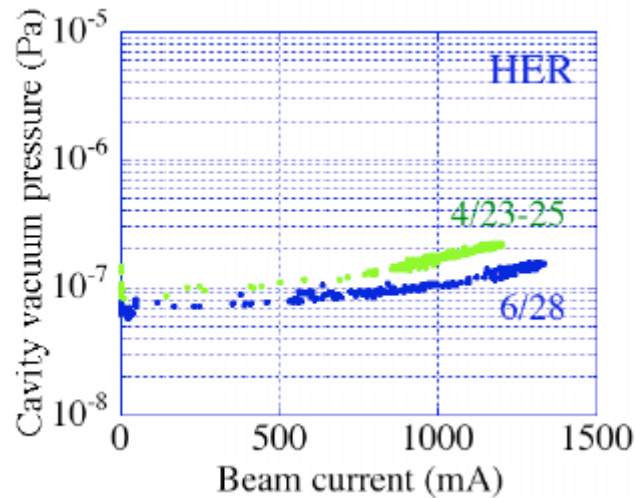
Improvements of vacuum pressure after warm-up

Vacuum pressure in each cavity improved after vacuum scrubbing and warmup to 300K
